Pentium® II Processor Specification Update

Release Date: August 1997

Order Number: 243337-004

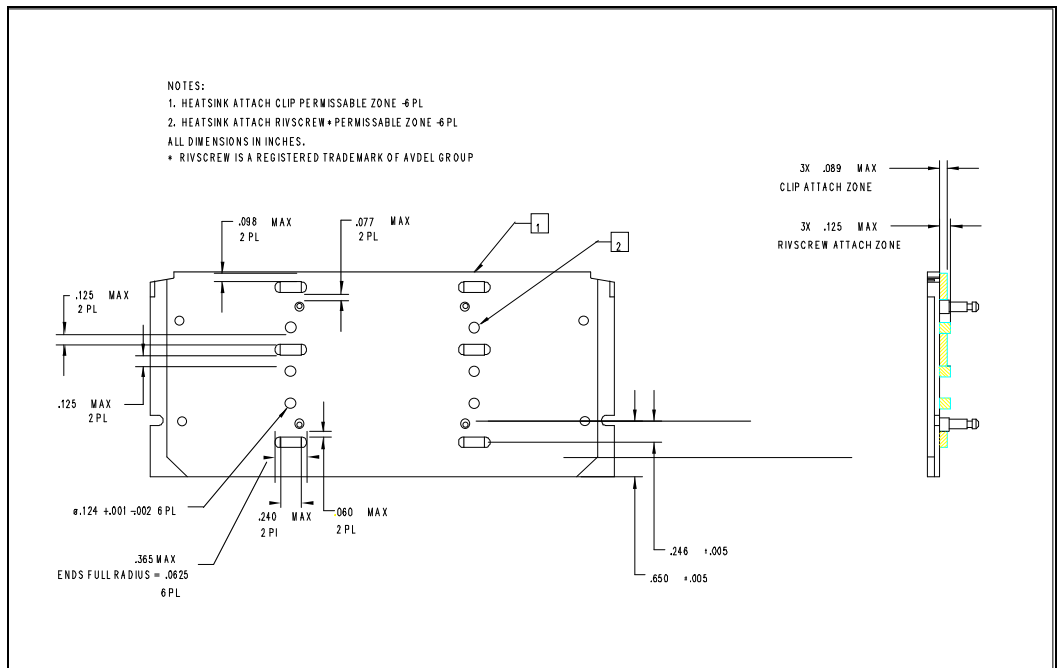
Figure 11. Heatsink Attachment Mechanism Design Space

A change to the attach mechanism specification is provided below. The original specification for clearance of heatsink attach solutions is provided in Section 4.3 (and Figure 23 and Figure 24) in the *Pentium® II Processor at 233 MHz, 266 MHz and 300 MHz* datasheet. Figure 11 shows the revised maximum specifications for heatsink clip and Rivscrew® attach mechanism designs. All heatsink clip and Rivscrew attachment solutions must remain within the respective maximum “permissible” zone as detailed in Figure 11.

The thermal plate shown in Figure 11 is used to portray the heatsink attach mechanism design space for the future Slot 1 processors. However, the maximum “permissible” design space is also valid for both the current Pentium II and future Slot 1 processors.

Please review the proposed specifications to guarantee compatibility with existing Pentium® II and future Slot 1 processor heatsink attachment solutions. Note that the required heatsink attachment solution space should not exceed the maximum proposed design space while installed or during the installation and removal procedure.
